**Flood Control Project Maintenance
Levee Inspections**

Maintenance Issue Types Only, Levee Inspection Report By Mile - Spring 2017

Sutter Maintenance Yard Maintenance Area 0017

Waterway	Bank	Unit Miles	Inspection Start/End	Inspector
Unit No. 01 Lake County Sutter Maintenance Yard - Middle Creek	Left	3.87	05/10/2017 05/10/2017	Bob Duffey

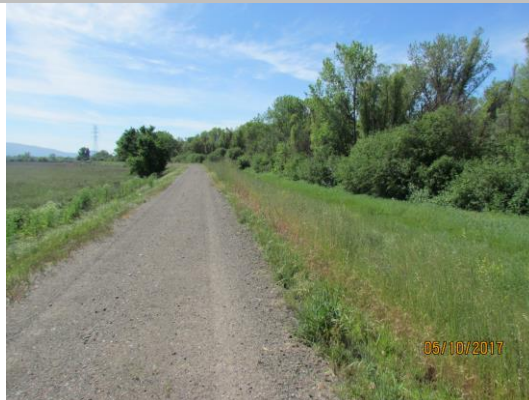
Photo 1 of 1 : SP_2017_MA0017_339_24_20170515_00042.jpg

LM Start	3.44	Rating **	A	Issue No.	24
LM End	3.44	Issue Type +	Ma	Location *	LS
Category	Earthen Levee		GPS Latitude/Longitude		
			Start	End	
Item	Vegetation		39.148593 °	39.148593 °	
			-122.911912 °	-122.911912 °	
DWR ID	DWR_MA0017_01_s_2017_24				
Comment Code					
V1 : Control annual grass and weeds on the levee slopes and easements.					
Inspector Comment					
There are native grasses on both slopes.

View of the native grasses on both slopes.

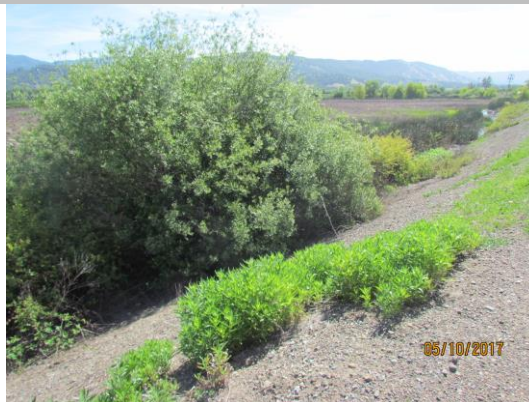
Photo 1 of 1 : SP_2017_MA0017_339_25_20170515_00043.jpg

LM Start	3.84	Rating **	M	Issue No.	25
LM End	3.84	Issue Type +	Ma	Location *	LS
Category	Earthen Levee			GPS Latitude/Longitude	
				Start	End
Item	Trim / Thin Trees			39.144695 °	39.144695 °
				-122.906668 °	-122.906668 °
DWR ID	DWR_MA0017_01_s_2017_25				
Comment Code					
T2 : Thin trees to allow visibility of the ground and room to flood fight.					
Inspector Comment					
Trim the trees along the landside toe.

View of the trees along the landside toe.

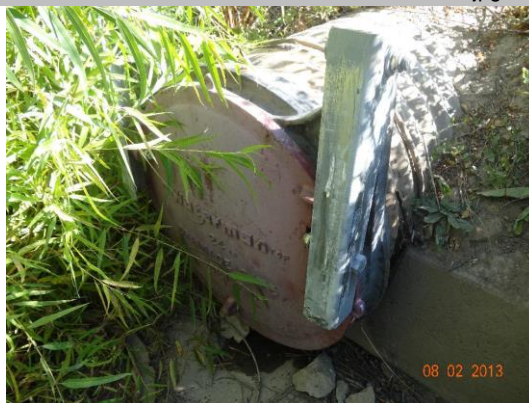
Photo 3 of 3 : UCIP_SP_2017_50814_46850.jpg

Item	DWR UCIP LMA Responsibility			39.143792 °	39.143792 °	
				-122.904798 °	-122.904798 °	
DWR ID						
Comment Code						
Inspector Comment						
FS_ID:50814 DS_ID:844 EP_NO: 11463 Repair Type: No Action Needed Crossing Status: Found UCIP Comments: 10/19/2016 Crossing appears to be in good ondition. (DWR Sutter Yard- A/Freitag)6/14/2016 crossing appears to be in good condition.4/23/2015 No issues with pipe.7/3/2014 Same as last inspection.12/23/2013 Same as last inspection.8/2/2013 New flap gate installed. No other issues with pipe. FIELD_STRUCT_DESC: 24-inch corrugated metal drainage pipe through the levee, 12.4 feet below the crown. Flap gate on the waterside (WS) end. Timber walkway on the landside (LS) slope to a timber walkway to pump house mounted on piles in drainage ditch. (Automatic Board Order (ABO) issued as Permit No. 11463, 1975 - Jones). [Additional Reference(s): DWR Levee Log, 2005. USACE Sacramento O&M Manual 506.2, August 1961, (HLM 3.99)]. FS Date: 11/21/2016 12:09:38 PM

New flap gate on WS

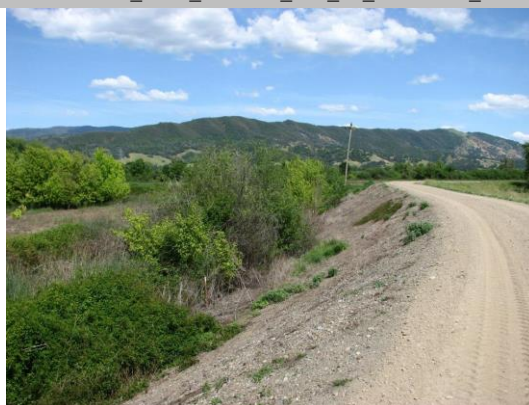
Photo 1 of 1 : SP_2017_MA0017_339_16_20170315_00004.jpg

LM Start	3.96	Rating **	M	Issue No.	16
LM End	4.03	Issue Type +	Ma	Location *	LS
Category	Earthen Levee			GPS Latitude/Longitude	
				Start	End
Item	Vegetation			39.143741 °	39.143585 °
				-122.904705 °	-122.903482 °
DWR ID	DWR_MA0017_01_s_2016_16				
Comment Code					
V2 : Remove the wild growth other than native grasses from the levee slopes.					
Inspector Comment					
Large bushes and brambles growing on wire fence on LS toe limiting visibility and access.

5/2/2016: Remove or trim dense vegetation growing on fence to allow visibility and access to L/S toe.

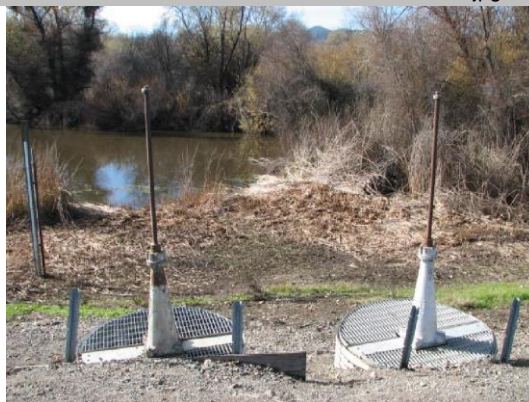
Photo 2 of 3 : UCIP_SP_2017_50815_46852.jpg

FS_ID:50815
DS_ID:845
EP_NO: 11464
Repair Type: No Action Needed
Crossing Status: Found
UCIP Comments: 10/19/2016 Crossing appears to be in good condition. (DWR Sutter Yard- A Freitag) 6/14/2016 crossing appears to be in good condition. 4/23/2015 No issues with pipe. 7/3/2014 Same as last inspection. 12/23/2013 Same as last inspection. 8/2/2013 Same as last inspection.
FIELD_STRUCT_DESC: [Bloody Island Pumping Plant] 1 of 2: 42-inch corrugated metal drainage pipe through the levee, 20.2 feet below the crown. Concrete headwall and discharge apron on the waterside (WS) shoulder. Three vertical pump units mounted on reinforced concrete pump platform in drainage ditch at the landside (LS) toe. Flap gates in concrete discharge well on the LS. Combination flap and slide gate on gravity pipe from drain ditch into discharge well. (Automatic Board Order (ABO) issued as Permit No. 11464, 1975 - Lake County)

Slide gates in CMP risers on WS shoulder.

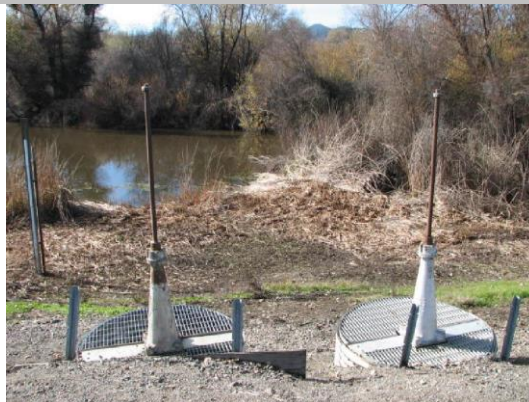
Photo 2 of 3 : UCIP_SP_2017_50816_46855.jpg

FS_ID:50816
DS_ID:852
EP_NO: 11464
Repair Type: No Action Needed
Crossing Status: Found
UCIP Comments: 10/19/2016 Crossing appears to be in good condition. (DWR Sutter Yard- A Freitag) 6/14/2016 crossing appears to be in good condition. 4/23/2015 No issues with pipe. 7/3/2014 Same as last inspection. 12/23/2013 Same as last inspection. 8/2/2013 Same as last inspection.
FIELD_STRUCT_DESC: [Bloody Island Pumping Plant] 2 of 2: 42-inch corrugated metal drainage pipe through the levee, 14.6 feet below the crown. Concrete headwall and discharge apron on the waterside (WS) shoulder. Three vertical pump units mounted on reinforced concrete pump platform in drainage ditch at the landside (LS) toe. Flap gates in concrete discharge well on the LS. Combination flap and slide gate on gravity pipe from drain ditch into discharge well. (Automatic Board Order (ABO) issued as Permit No. 11464, 1975 - Lake County)

Slide gate in CMP riser on WS shoulder.

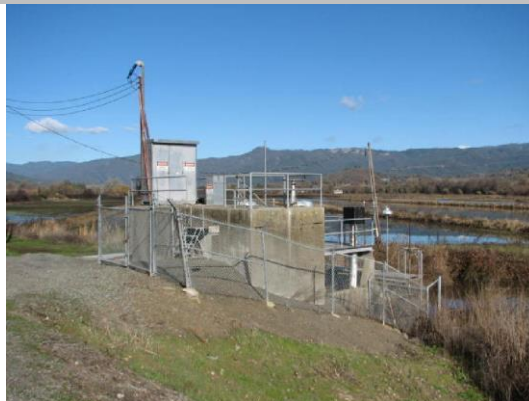
Photo 3 of 3 : UCIP_SP_2017_50816_46854.jpg

Comment Code					
Inspector Comment					
FS_ID:50816 DS_ID:852 EP_NO: 11464 Repair Type: No Action Needed Crossing Status: Found UCIP Comments: 10/19/2016 Crossing appears to be in good condition. (DWR Sutter Yard- A Freitag)6/14/2016 crossing appears to be in goioid condition.4/23/2015 No issues with pipe.7/3/2014 Same as last inspection.12/23/2013 Same as last inspection.8/2/2013 Same as last inspection. FIELD_STRUCT_DESC: [Bloody Island Pumping Plant] 2 of 2: 42-inch corrugated metal drainage pipe through the levee, 14.6 feet below the crown. Concrete headwall and discharge apron on the waterside (WS) shoulder. Three vertical pump units mounted on reinforced concrete pump platform in drainage ditch at the landside (LS) toe. Flap gates in concrete discharge well on the LS. Combination flap and slide gate on gravity pipe from drain ditch into discharge well. (Automatic Board Order (ABO) issued as Permit No. 11464, 1975 - Lake County) [Additional Reference(s): DWR Levee Log, 2005. USACE Sacramento O&M Manual 506.2, August 1961, (HLM 4.18)]. FS Date: 11/21/2016 12:11:01 PM

Pumping plant on LS shoulder.

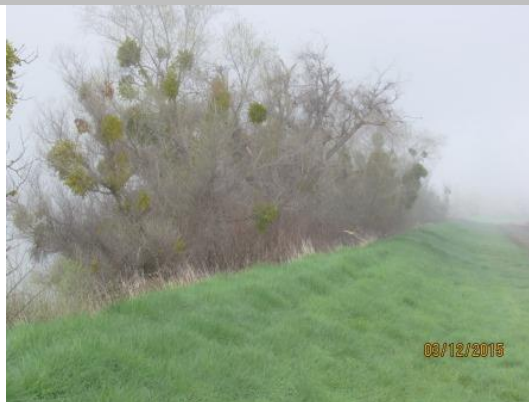
Photo 1 of 2 : SP_2017_MA0017_339_2_20170315_00001.jpg

LM Start	4.16	Rating **	U	Issue No.	2
LM End	7.10	Issue Type +	Ma	Location *	WS
Category	Earthen Levee			GPS Latitude/Longitude	
				Start	End
Item	Trim / Thin Trees			39.141894 °	39.120609 °
				-122.902201 °	-122.887166 °
DWR ID	DWR_MA0017_01_s_2012_2				
Comment Code					
T2 : Thin trees to allow visibility of the ground and room to flood fight.					
Inspector Comment					
Trees and limbs are completely obstructing visibility on crown and WS. Crown is too narrow to drive, and overgrown with weeds, brush and trees. Road follows LS toe.

View of the trees along the waterside slope and toe.

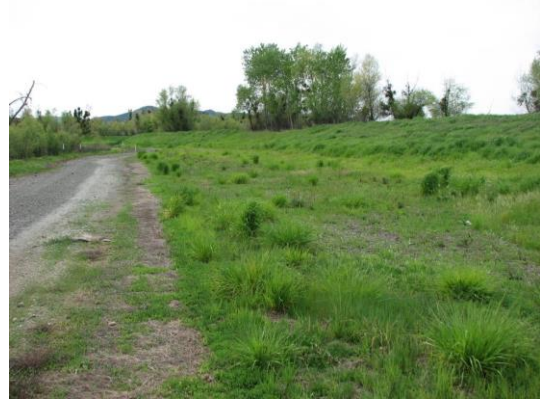
Photo 2 of 2 : SP_2017_MA0017_339_2_20170315_00002.jpg

LM Start	4.16	Rating **	U	Issue No.	2 (cont)	
LM End	7.10	Issue Type +	Ma	Location *	WS	
Category	Earthen Levee			GPS Latitude/Longitude		
				Start	End	
Item	Trim / Thin Trees			39.141894 °	39.120609 °	
				-122.902201 °	-122.887166 °	
DWR ID	DWR_MA0017_01_s _ 2012_2					
Comment Code						
T2 : Thin trees to allow visibility of the ground and room to flood fight.						
Inspector Comment						
Trees and limbs are completely obstructing visibility on crown and WS. Crown is too narrow to drive, and overgrown with weeds, brush and trees. Road follows LS toe.

Photo taken at LM 6.41 looking west showing overgrown LS slope of levee at right and toe road at left. Note trees obstructing visibility and access at levee crown. Crown is +/- 5 feet wide, and impassible to vehicles due to vegetation, and in some places, to pedestrians.
4/19/2016

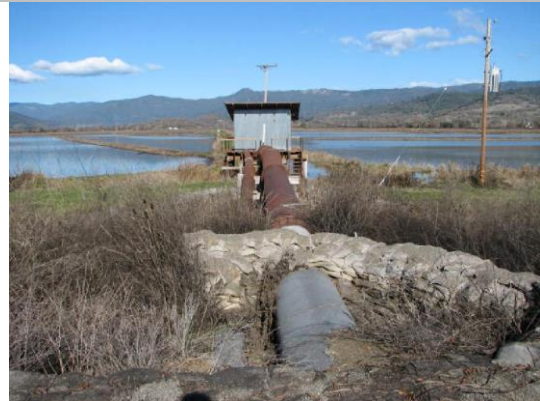
Photo 1 of 2 : UCIP_SP_2017_50818_46860.jpg

Comment Code					
Inspector Comment					
FS_ID:50818 DS_ID:847 EP_NO: 11469 Repair Type: Non-Urgent Crossing Status: Found UCIP Comments: 10/19/2016 Sack ring still in place. (DWR Sutter Yard- A Freitag)6/14/2016 Sack ring is still built up underneath the pipes.4/23/2015 Sack ring is still built up underneath the pipes.7/3/2014 Same as last inspection.12/23/2013 Same as last inspection.8/2/2013 Same as last inspection.12/13/2012 flood fight materials-ring levees around both LS and WS slopes at pipe crossing. This may or may not be an issue. FIELD_STRUCT_DESC: 1 of 2: 16-inch steel drainage pipe through the levee, 5 feet below the crown. Drainage pumping plant on the landside (LS). Flap gate on the waterside (WS) end. (Automatic Board Order (ABO) issued as Permit No. 11469, 1975 - RD 2070). [Additional Reference(s): DWR Levee Log, 2005. USACE Sacramento O&M Manual 506.3, August 1961, (HLM 5.43)]. FS Date: 11/21/2016 12:11:57 PM

Pumping plant, pipes, and ring levees on LS toe.

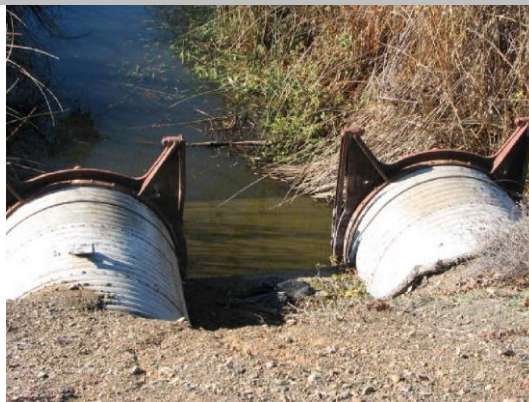
Photo 2 of 3 : UCIP_SP_2017_50821_46868.jpg

FS_ID:50821
DS_ID:849
EP_NO: 11467
Repair Type: No Action Needed
Crossing Status: Found
UCIP Comments: 10/19/2016 Crossing appears to be in good condition. (DWR Sutter Yard- A Freitag)6/14/2016 Flap gate propped open. Will make sure its closed before flood season.4/23/2015 Flap gate propped open. Not an issue at this time. Will close it before high water season.7/3/2014 Same as last inspection12/23/2013 Same as last inspection.8/2/2013 Same as last inspection.
FIELD_STRUCT_DESC: 1 of 2: 54-inch corrugated metal drainage pipe through the levee 11.5 feet below the crown. Highland Canal Diversion Weir and Drainage Structure on the landside (LS). Concrete headwall on both landside (LS) and waterside (WS) toe with flap gate on the WS toe. (Automatic Board Order (ABO) issued as Permit No. 11467, 1975 - Modglin). [Additional Reference(s): DWR Levee Log, 2005. USACE Sacramento O&M Manual 506.3, August 1961, (HLM 6.05)].

pipe and flap gate on WS toe.

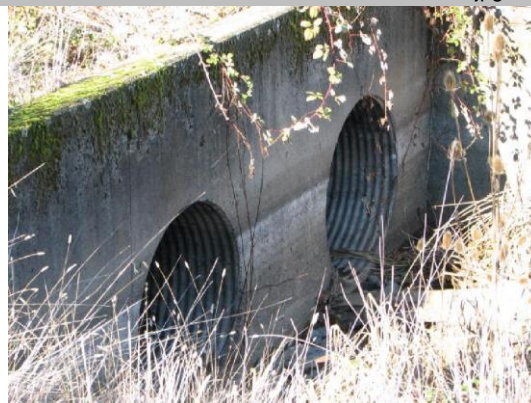
Photo 3 of 3 : UCIP_SP_2017_50821_46867.jpg

FS_ID:50821
DS_ID:849
EP_NO: 11467
Repair Type: No Action Needed
Crossing Status: Found
UCIP Comments: 10/19/2016 Crossing appears to be in good condition. (DWR Sutter Yard- A Freitag)6/14/2016 Flap gate propped open. Will make sure its closed before flood season.4/23/2015 Flap gate propped open. Not an issue at this time. Will close it before high water season.7/3/2014 Same as last inspection12/23/2013 Same as last inspection.8/2/2013 Same as last inspection.
FIELD_STRUCT_DESC: 1 of 2: 54-inch corrugated metal drainage pipe through the levee 11.5 feet below the crown. Highland Canal Diversion Weir and Drainage Structure on the landside (LS). Concrete headwall on both landside (LS) and waterside (WS) toe with flap gate on the WS toe. (Automatic Board Order (ABO) issued as Permit No. 11467, 1975 - Modglin). [Additional Reference(s): DWR Levee Log, 2005. USACE Sacramento O&M Manual 506.3, August 1961, (HLM 6.05)].

Concrete headwall at inlet on LS toe.

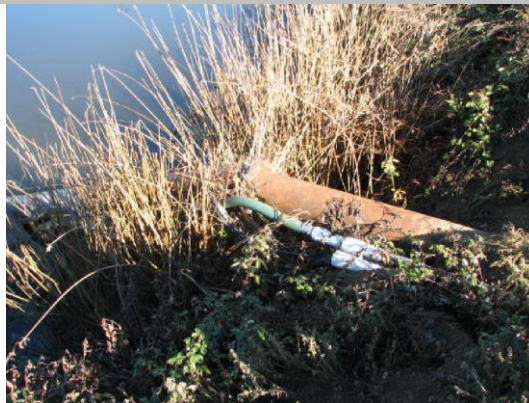
Photo 1 of 3 : UCIP_SP_2017_50826_46882.jpg

FS_ID:50826
 DS_ID:850
 EP_NO: 11467
 Repair Type: Urgent
 Crossing Status: Found
 UCIP Comments: 10/19/2016 WS erosion still present. (DWR Sutter Yard - A Freitag) 6/14/2016 WS erosion is still present. (DWR Sutter Yard - a Freitag) 4/23/2015 Same as last inspection. (DWR Sutter Yard - a Freitag) 7/3/2014 Same as last inspection. (DWR Sutter Yard - a Freitag) 12/23/2013 Same as last inspection. (DWR Sutter Yard - a Freitag) 8/2/2013 Same as last inspection. (DWR Sutter Yard - a Freitag) 12/13/2012 This pipe and appurtances do not match what was described in the permit (PN: 11467). Does not appear to be in compliance with board regulations. (DWR UCIP - wwyllie)
 FIELD_STRUCT_DESC: 12-inch steel drainage pipe through the levee, 2-feet below the crown. Butterfly valve on the landside (LS) shoulder. Pump and electric panel along with multiple valves and appurtances on the LS shoulder. (Automatic Board Order (ABO) issued as Permit No. 11467, 1975 - Modglin). [Additional Reference(s): DWR Levee Log, 2005. USACE Sacramento O&M Manual 506.3, August 1961, (HLM 6.11)].

12-inch pipe and appurtances on WS shoulder.

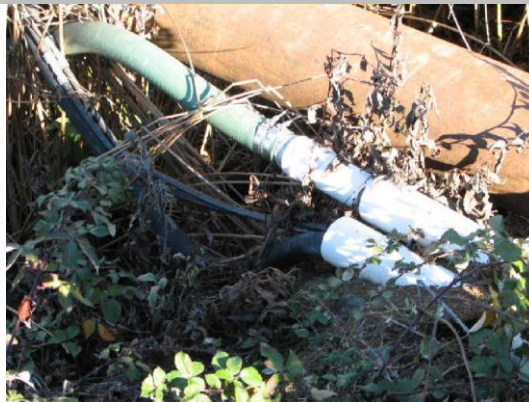
Photo 2 of 3 : UCIP_SP_2017_50826_46881.jpg

12-inch pipe and appurtances on WS shoulder.

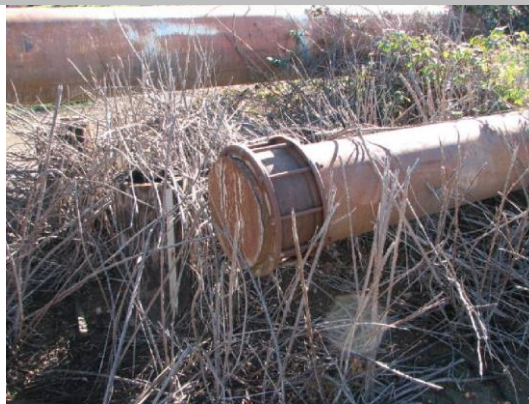
Photo 2 of 2 : UCIP_SP_2017_50827_46883.jpg

FS_ID:50827
 DS_ID:851
 EP_NO: 11467
 Repair Type: Non-Urgent
 Crossing Status: Found
 UCIP Comments: 10/19/2016 Abandoned- should be done so properly.
 (DWR Sutter Yard- A Freitag)6/14/2016 Abandoned
 crossing.4/23/2015 Same as last inspection. Pipe still needs to be
 properly abandoned.7/3/2014 Same as last inspection.12/23/2013
 Same as last inspection.8/2/2013 Same as last
 inspection.12/13/2012 Pipe should be properly abandoned.
 FIELD_STRUCT_DESC: *ABANDONED* 1 of 2: 16-inch steel drainage
 pipe through the levee, 8 feet below the crown. Drainage pumping plant
 on the landside (LS). Flap gate on the waterside (WS) end. Steel
 plate welded on end of pipe at LS toe. (Automatic Board Order (ABO)
 issued as Permit No. 11467, 1975 - Modglin). [Additional
 Reference(s): DWR Levee Log, 2005. USACE Sacramento O&M
 Manual 506.3, August 1961, (HLM 7.19)].
 FS Date: 11/21/2016 12:16:52 PM

Steel plate welded over end of pipe at LS toe.
